Upstate Update

Hudson Valley, N.Y.

Kate Johns, AIA

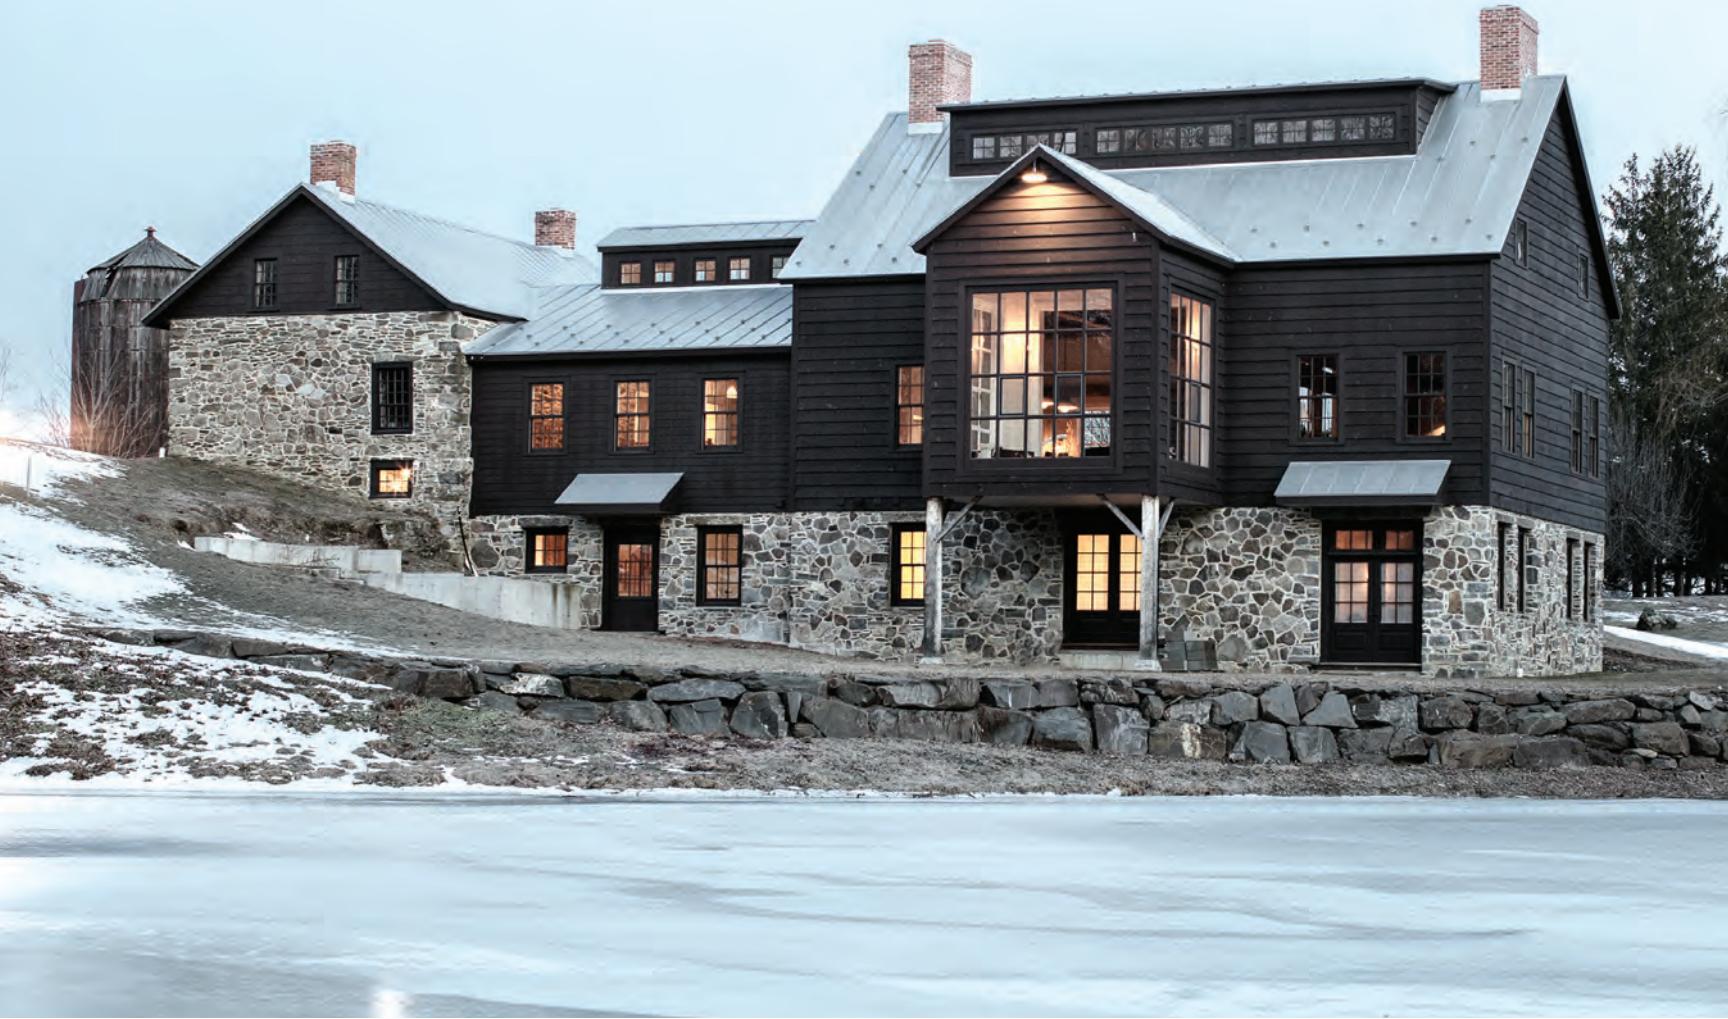
Architect Kate Johns built a connector structure between the farm's original house (left) and main barn so as to create a grand enfilade—a series of connected rooms running the length of the structure, reminiscent of the manor houses of Europe.

backs on the old stone house, but to make it open up to the barn structure," Johns explained. "By means of the connector and the double stairs and the discovery of an original second door in the rear of the old stone house, we're now able to see an enfilade all the way through the combined structure from a front window in the old stone house to a window in the end of the barn reconstruction. The circulation flows."

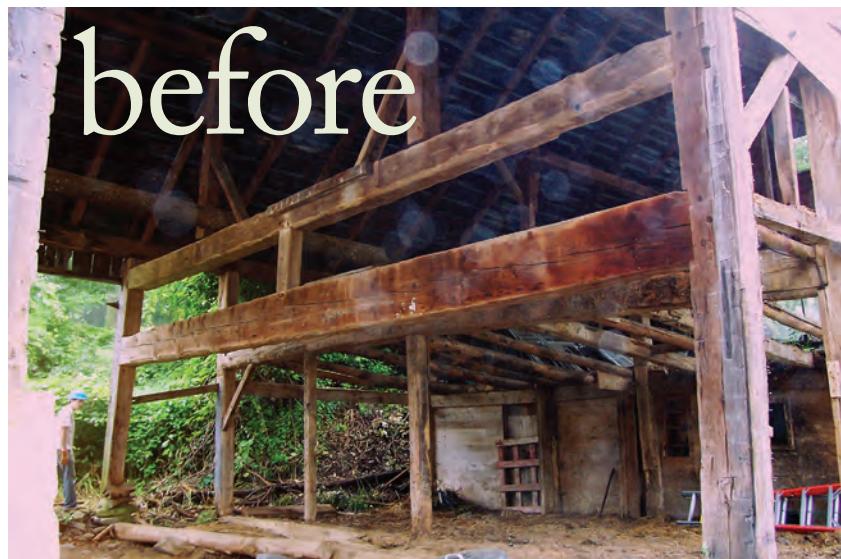
A before shot of the barn, stripped of its walls and ready for renovation.

Johns removed the original hayloft and restored and stabilized the barn's 200-year-old timber. After much research and discussion, she and her clients decided to utilize SIPs (Structural Insulated Panels) to insulate the roof, but not the walls. Instead they constructed brand-new interior walls around the beautiful old structural beams and posts to hide wiring and insulation, then layered a new exterior over that.

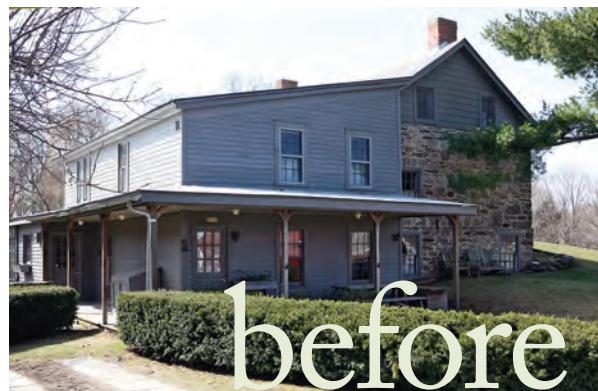
The original house, prior to the removal of the wood addition to make way for the new connector to the barn.

Johns' clients had lived in their farm's original dwelling for years but craved more space for entertaining, so the architect razed a non-original wood addition to the stone house to make way for a link between the original home and main barn in such a manner as to respect the integrity of both. It was

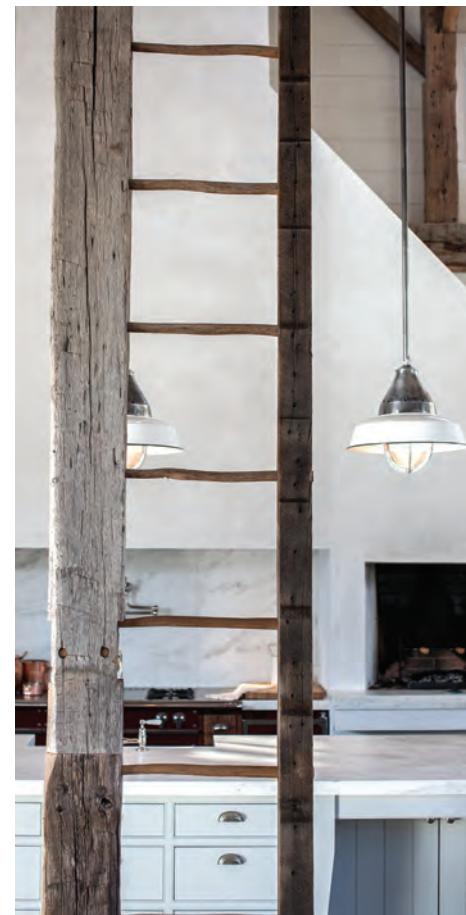
The old hand-hewn hayloft ladder built into the side of a timber support remains.

are key to the aesthetic because, said Johns, the question posed in barn projects is how to balance a residential feel while still respecting the barn aesthetic. To this end, she left structural posts and beams exposed, as well as the old hayloft ladder.
